More roof examples

TAYLOR
Made Plans
Residential Design
www.taylormadeplans.com

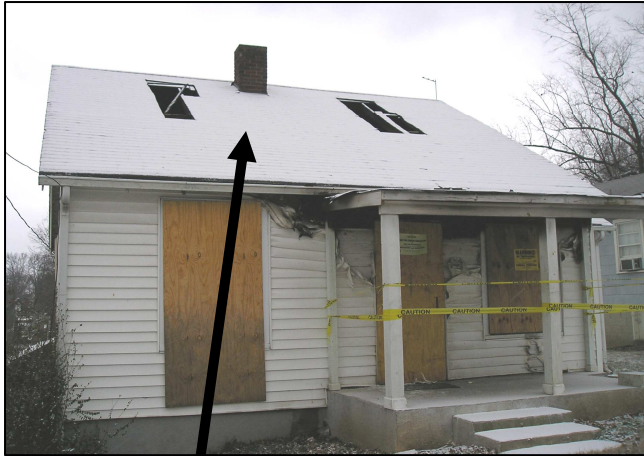
Vacant house - no melted snow here

Notice how the snow is still on the front porch roof...I will talk to you about this in slide 4.

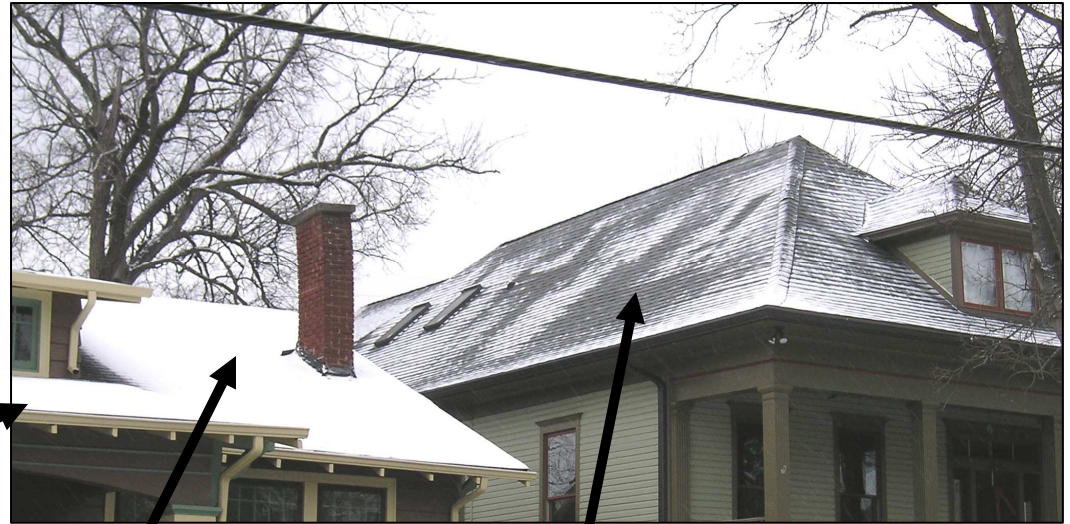
No melted snow here...they have attic insulation.

The insulation in the vaulted ceiling may not have been installed properly; it is only partially working.

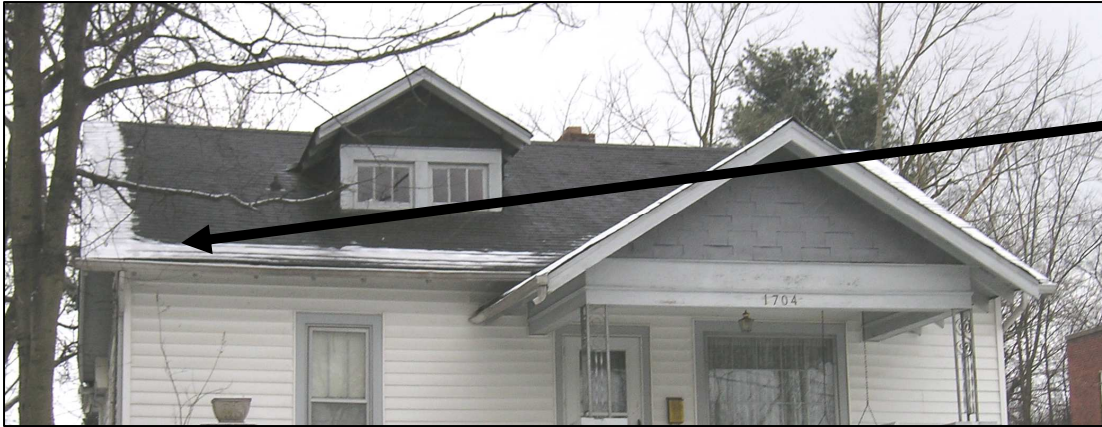
Melted snow here...no insulation or not enough

Notice how straight the snow line is on the roof eaves.

The heat from the first or second floor rises to the roof rafters and melts the snow quickly.

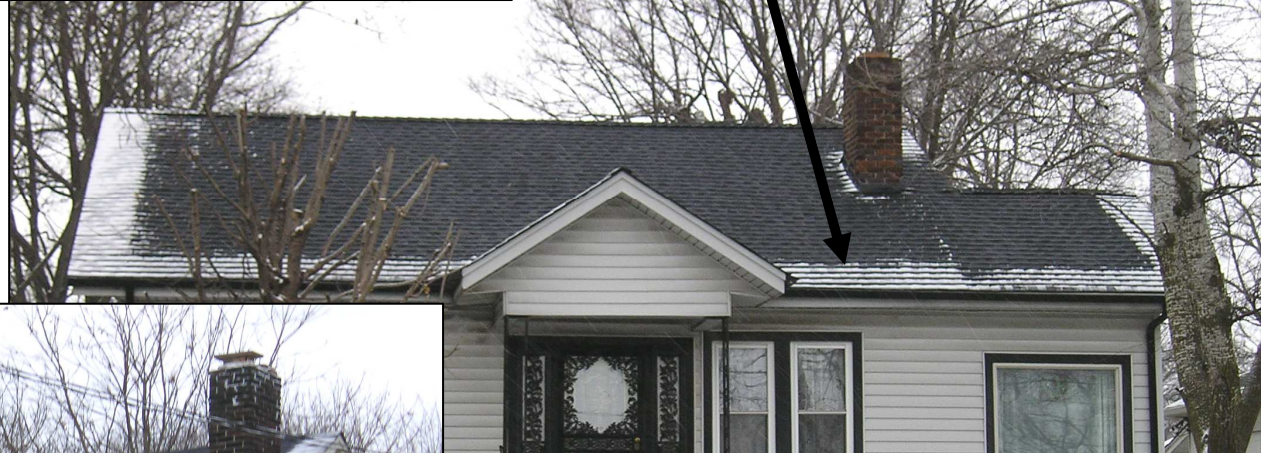
Some of the insulation is working between the 2x roof rafters

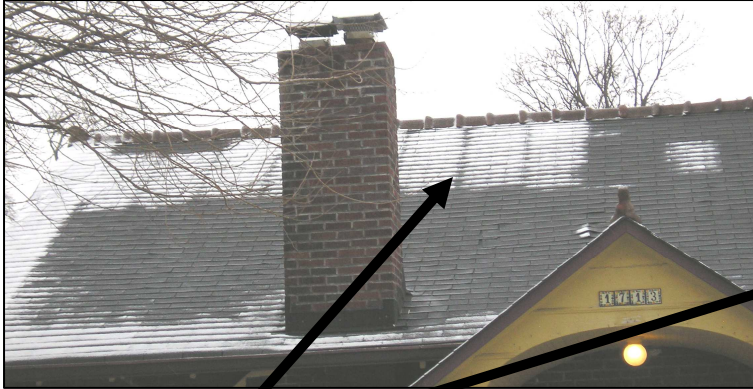
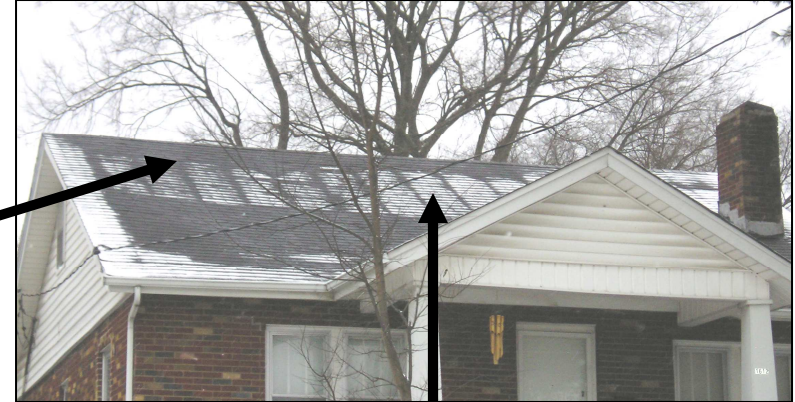
These lines are the 2x roof rafters, which are transferring the heat to the roof.

Notice how straight the snow line is on the roof eaves.

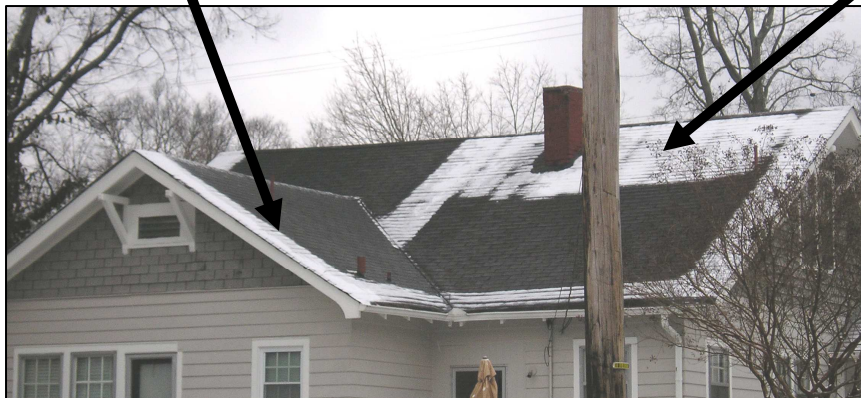
Some of the insulation is working and some may not have been installed properly.

Some of the insulation is working between the 2x roof rafters

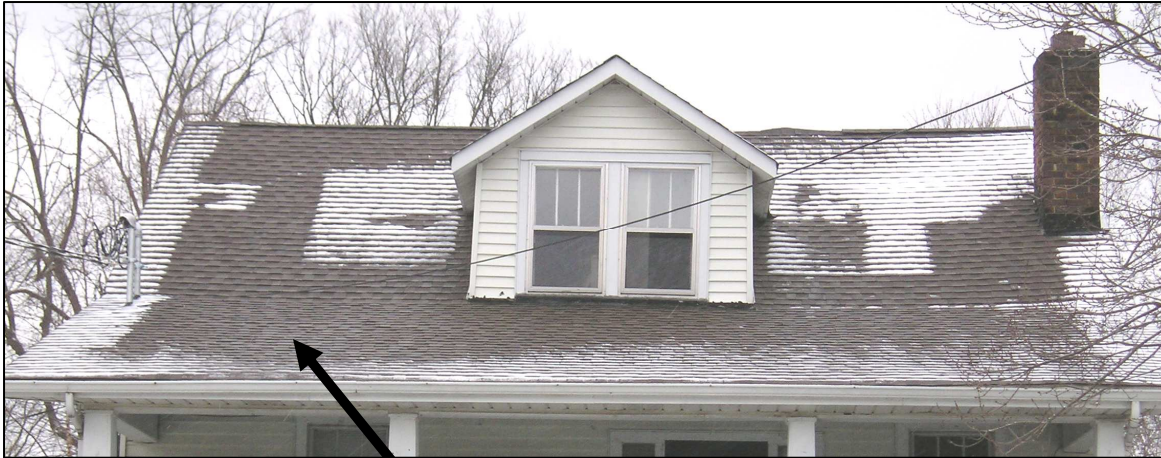
Notice how the snow is melted over the front porch roof...it should not melt because it is over an exterior space.

My theory...the knee wall in the second floor has no insulation and the heat is transferring to the porch roof and melting the snow.

The snow is still on the front porch

No insulation here...the roof was wet from the melting snow.

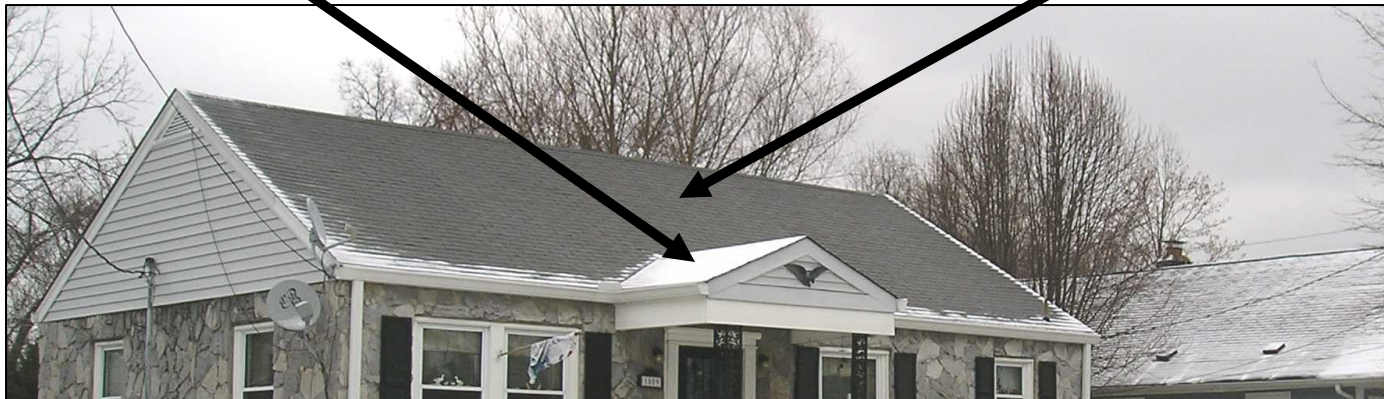
These attics have insulation

Icynene Insulation System

(<http://www.icynene.com>) was installed on the vaulted ceiling during construction of this new home.

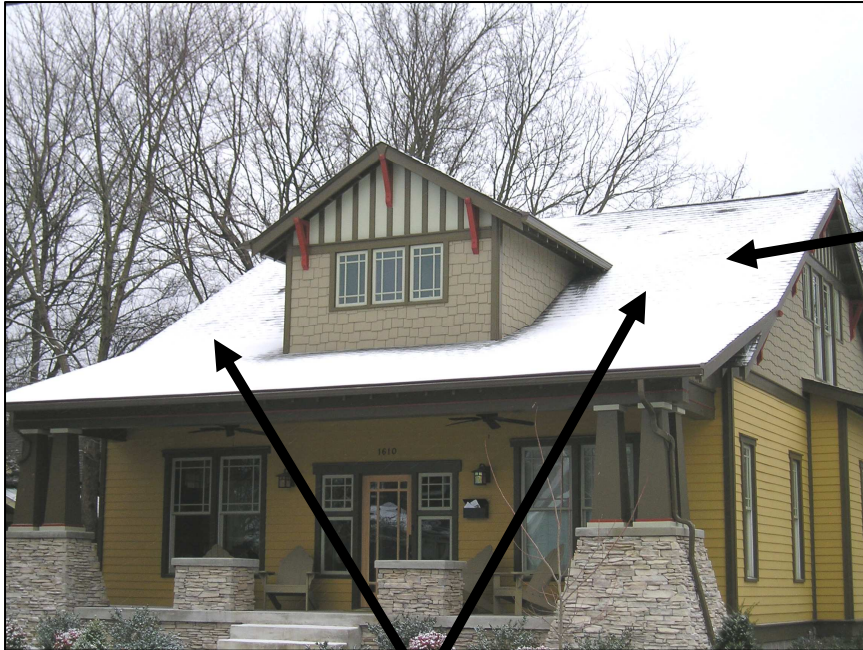
The snow is still on the front porch and the second floor roof.

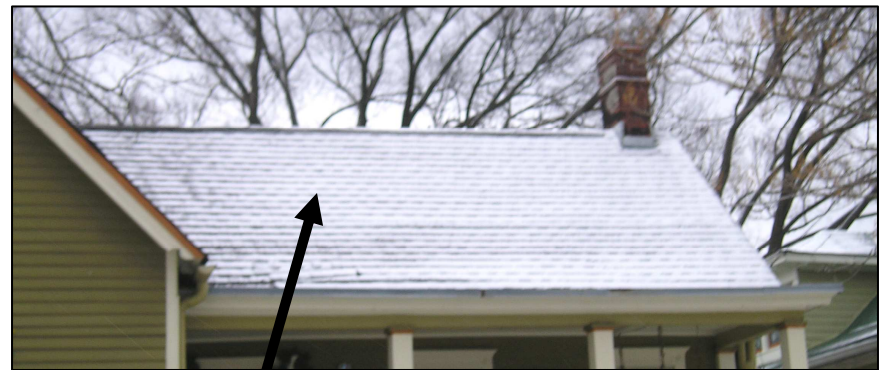
My personal that home I sold over two years ago...I installed loose insulation in the attic.
